Summary of an Offshore Inspection Campaign with Subsea CT Scanning Technology

Overview

- December 2014 offshore integrity campaign
- Corrosion assessment of ~7 year old flowline
- Increasing water cut, uncertain corrosion models
- Single well, 6" tieback targeted for extended life
 - ~1,650' water depth, ~3 miles to Host
- Volumetric metal loss known, but CT imaging used to confirm wall thickness

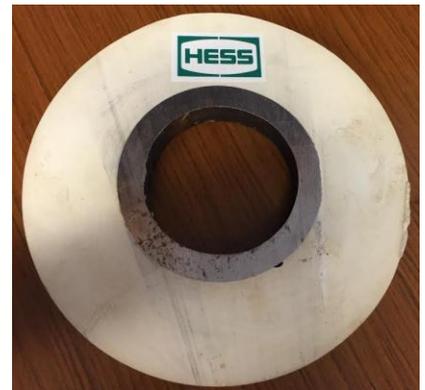
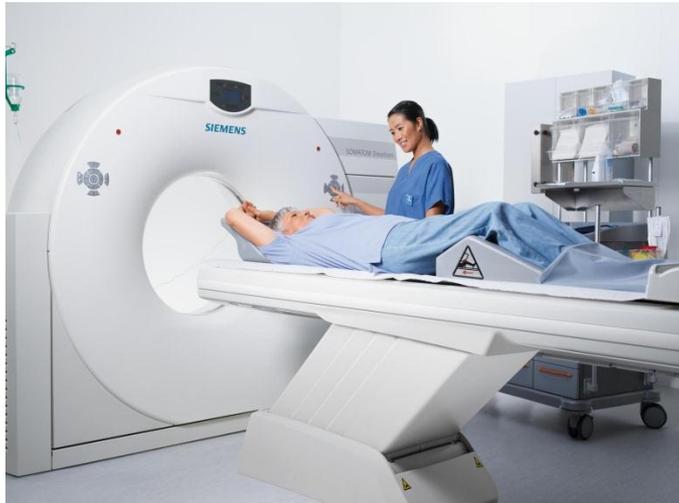
- Deliver value by ensuring integrity for extended life
- Needed non-intrusive, detection under insulation, no impact to production
- Pulsed Eddy Current (PEC) in 2013
 - Results positive, but volumetric only (no w.t. data)
- Re-validate / baseline corrosion models after water breakthrough

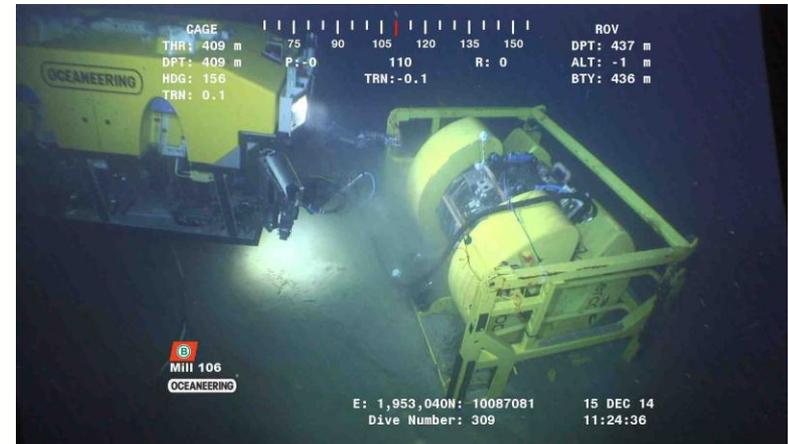
Subsea CT Scanning Tool

- New technology – 1st of its kind
- Hess – 2nd operator to use in GOM
- Non-intrusive, no impact to production
- ROV deployed
- Scan up to 27” OD with insulation (radial)
- 15 mm scan cross-section (longitudinal)
- Resolution +/- 1 mm (w.t.)

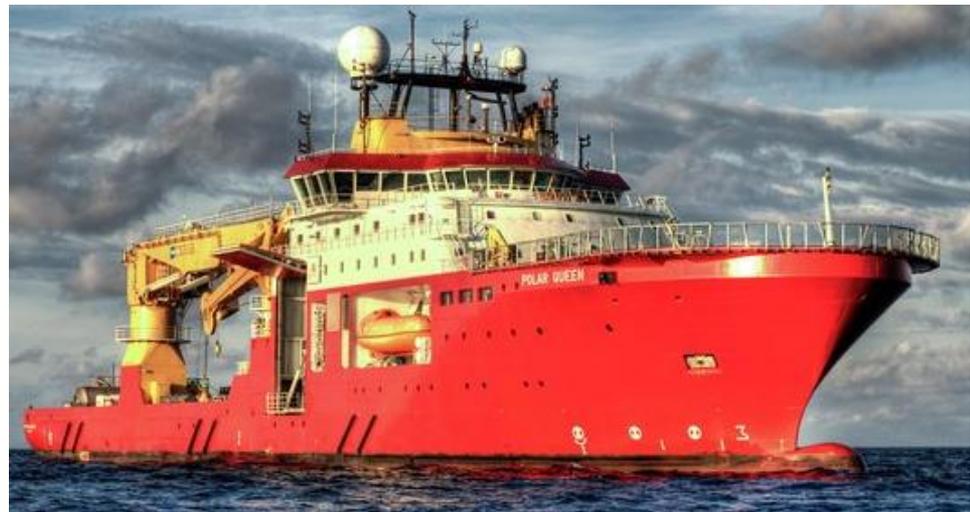
CT Scan Locations

**3 Scan Locations – 4 Scans/Location*

1. Near PLET

- Warmest, highest corrosion potential

2. Riser Base

- Most liquid accumulation

3. Riser

- Thicker wall pipe

**Locations consistent with PEC volumetric measurements*

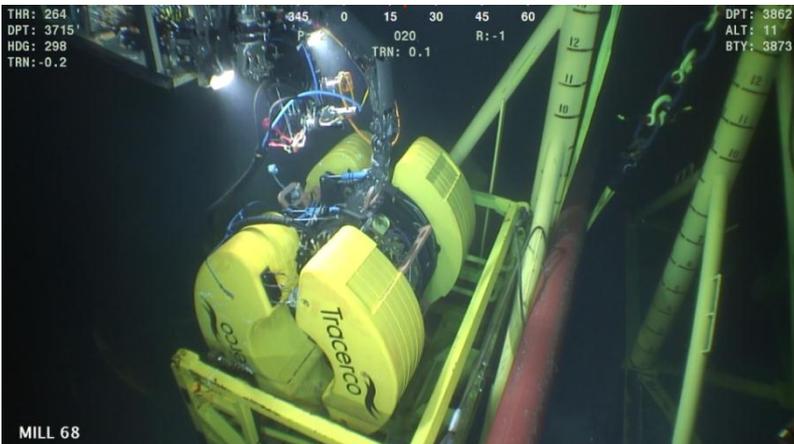
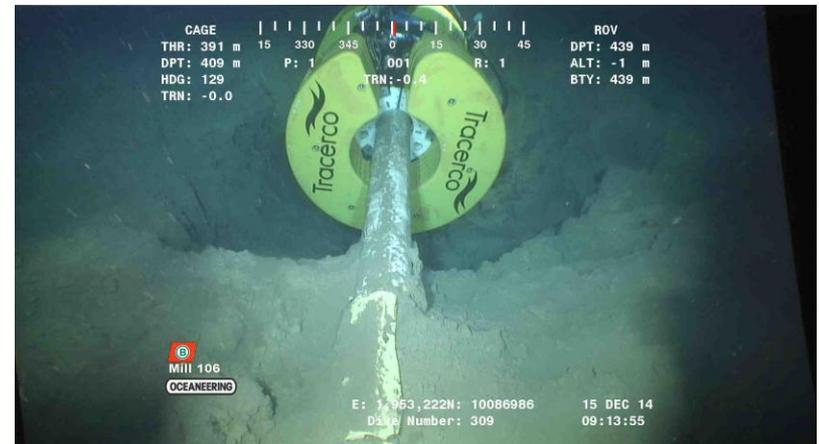
Site Prep

- Either lifting or dredging is typically required
- Elected to dredge with ROV pump
- ~1 day on each location for tool clearance
 - < 2 hours for each set of scans (4 scans/location)

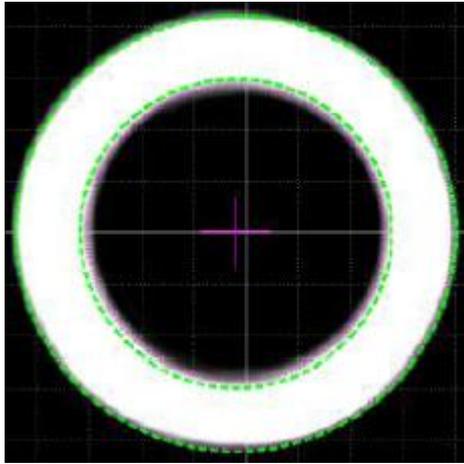
Riser: < 10% loss

- No evidence of accelerated internal corrosion
- Confirmed PEC data and field life extension
- Flow assurance became more of a concern

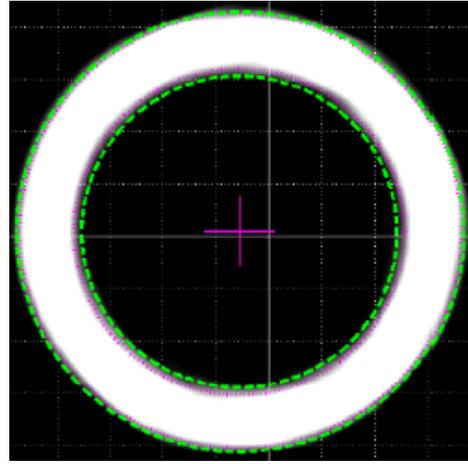
Riser Base: < 10% loss

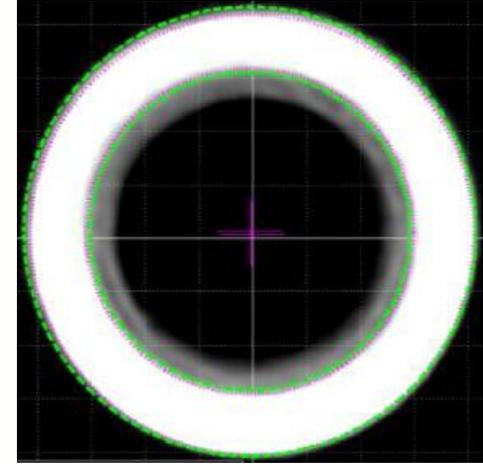
PLET: 0 to 14% loss

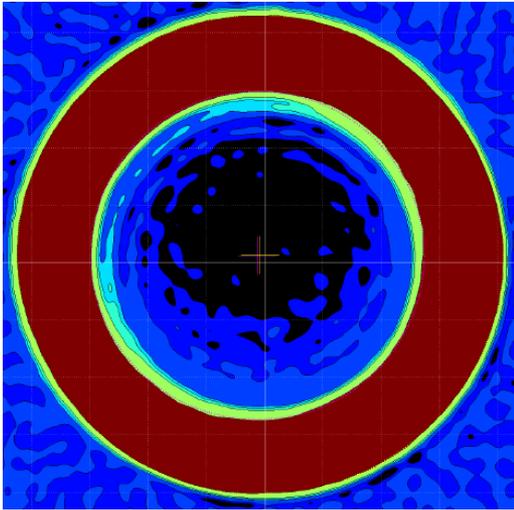
Riser

- Confirmed annular flow regime – water wet
- Unexpected internal build-up at PLET area

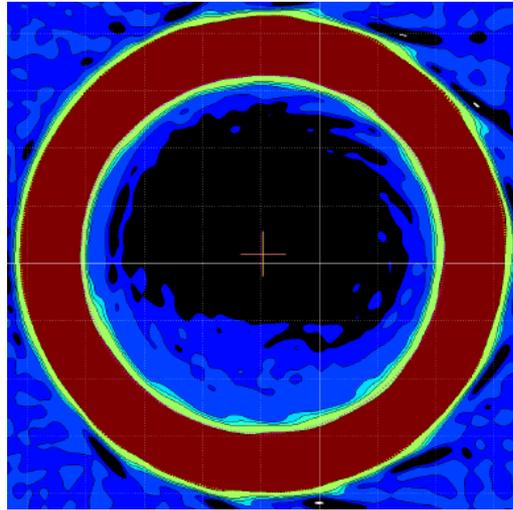
Riser Base

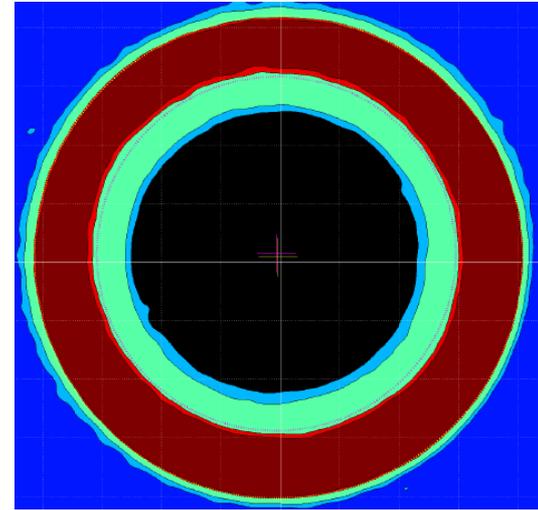
PLET

- Build-up concentric, density 3 – 5 g/cc
- Flowing Conditions: 4000 psi - 200°F
 - Rules out hydrate or paraffin build-up
- No asphaltene history
 - 1.2 g/cc
- No sand issues
 - 1.9 g/cc
- Medium Scaling Risk
 - 4.5 g/cc

- Increased coupon monitoring frequency
- Worked with chemical vendor to qualify inhibitor
- Scanning Electron Microscopy (SEM) used to evaluate particle size and growth
- **SEM testing (pre-inhibitor)**
 - Confirmed large particles with active growth
- **SEM testing (post-inhibitor)**
 - Indicates much smaller particles with no active growth

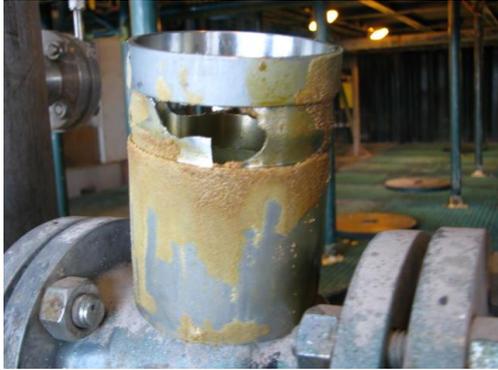
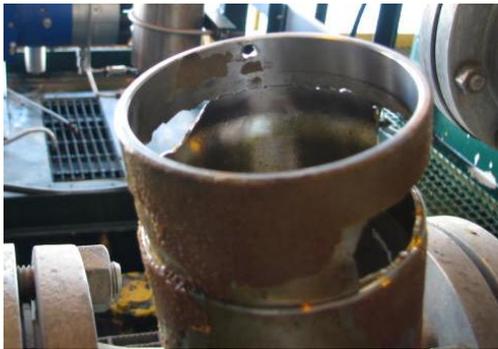
Scale in Boarding Choke

- Choke maintenance in Jan 2015 revealed a thin build up
- Build-up tested & determined to be scale, **BaSO₄**
- Evaluated addition of scale inhibitor to chemical injection program

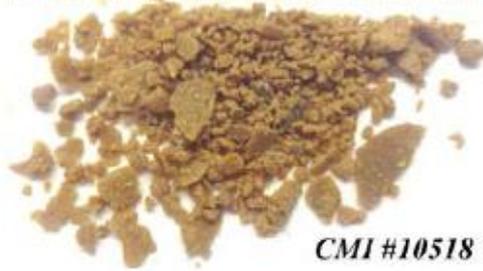
Sample ID		Mineral Phases Identified by XRD

CMI #10518		Quartz (SiO ₂)	K-feldspar (KAlSi ₃ O ₈)	Plagioclase (NaAlSi ₃ O ₈)	Siderite (FeCO ₃)	Calcite (CaCO ₃)	Barite (BaSO₄)	Halite (NaCl)	Non-Diffractive Organic Solids	Total
		NORM Scale Sample	10518	ND	ND	ND	ND	96	1	3
