# Fife, Fergus, Flora and Angus Fields Decommissioning Programmes

Close-Out Report

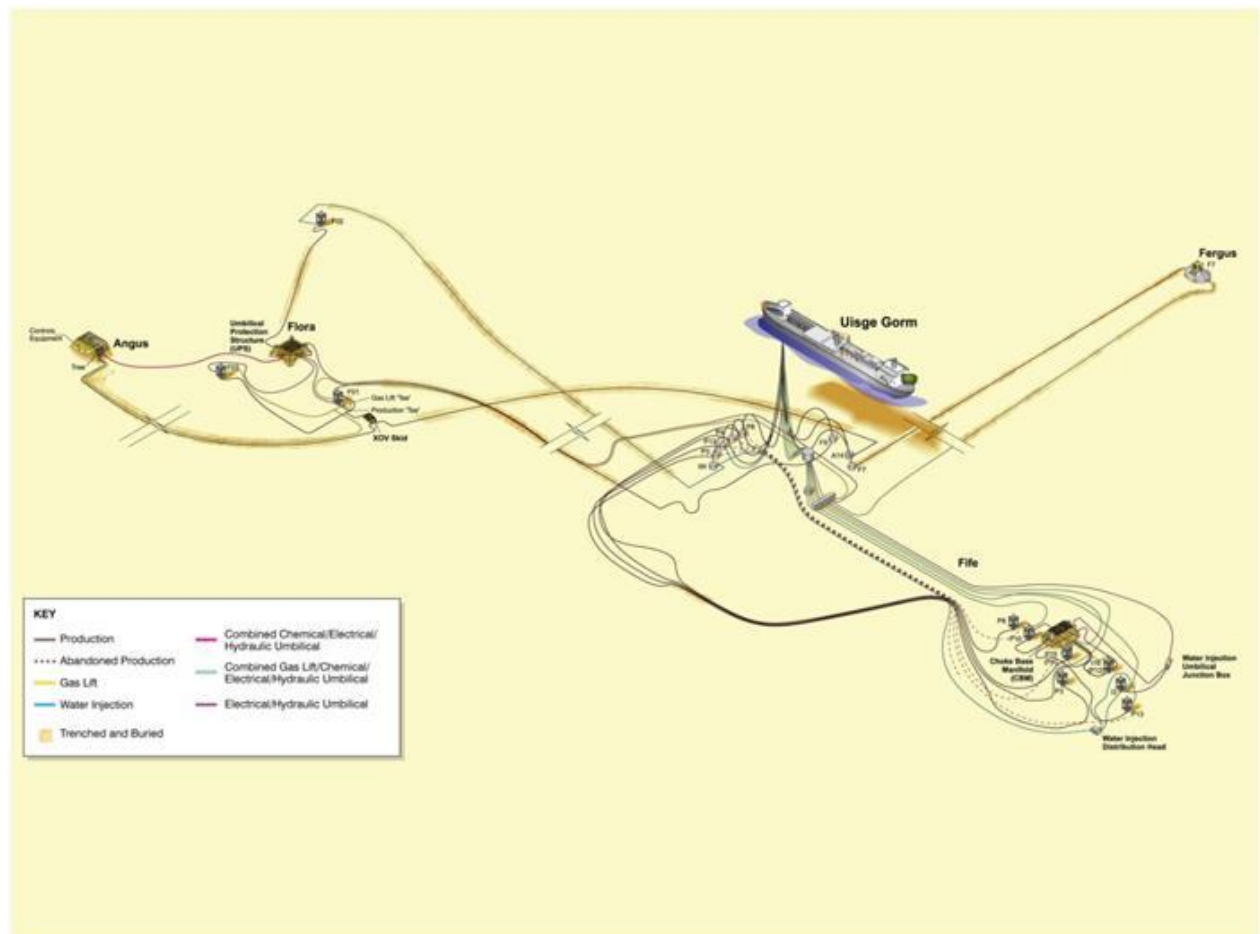
**Figure 2 FFFA Fields Layout Schematic (Pre-Decommissioning)**

The Fife, Fergus and Flora fields came on stream between 1995 and 1998 and were located approximately 18 km south-east of Angus, the *Uisge Gorm* was located in the central Fife area and in operation for 13 years. Table 2 provides an overview of the fields that made up the development, and Figures 1 and 2 provide a schematic overview of the location and initial layout of the fields.

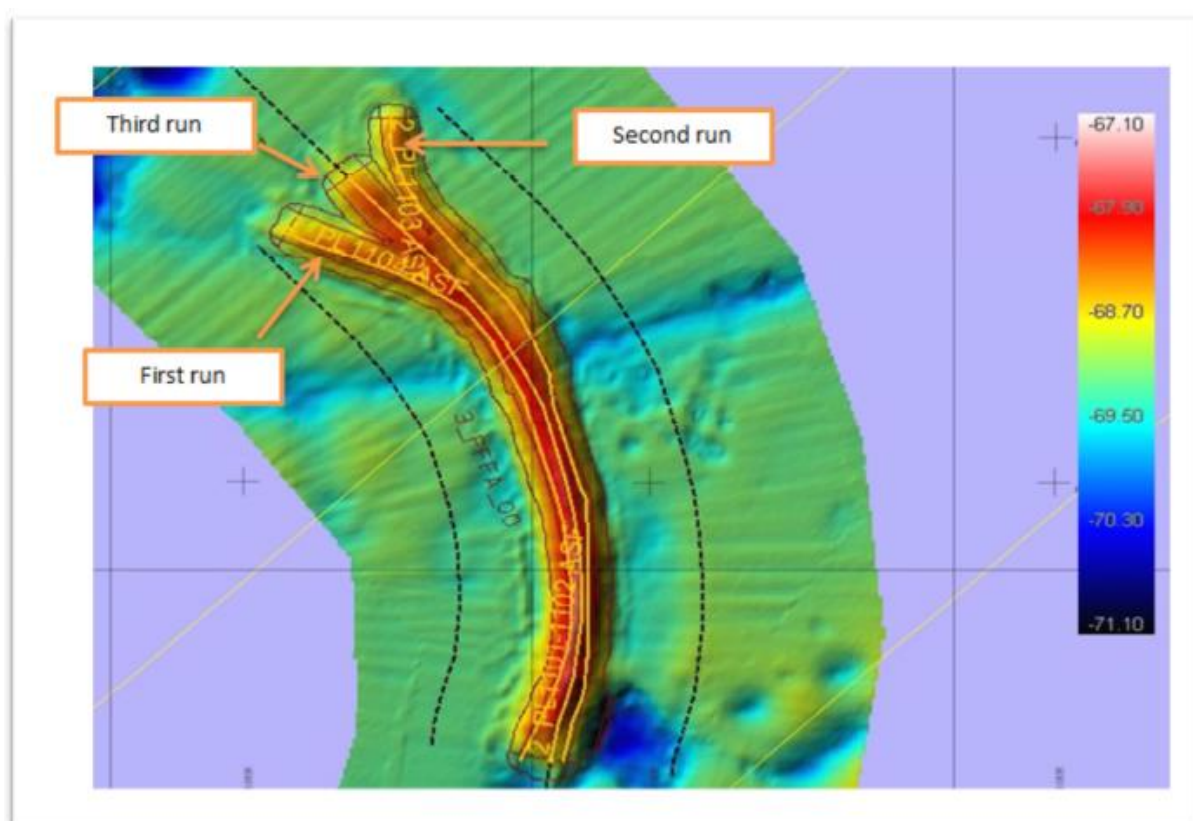
**Figure 5 As-Built Survey Screen Shot, Final Profile**

Due to complex SRI design at the FFFA location it was decided to work with three dumping lines. The first two runs were made with an offset of 0.7m on either side of the dumping line and a third run in middle (see Figures 5 and 6). After a visual check, the last rectifications were completed at lower rates.

1. Carry out a full as-found survey of the mattresses and adjacent seabed to be covered.
2. Rock dump over all mattresses, including any cut pipeline ends, ensuring a minimum cover of 600mm and a berm gradient of 1 in 3.
3. Rock dump is to be a smoothly contoured mound over the mattresses.
4. Carry out an as left survey of the rock dumped area.

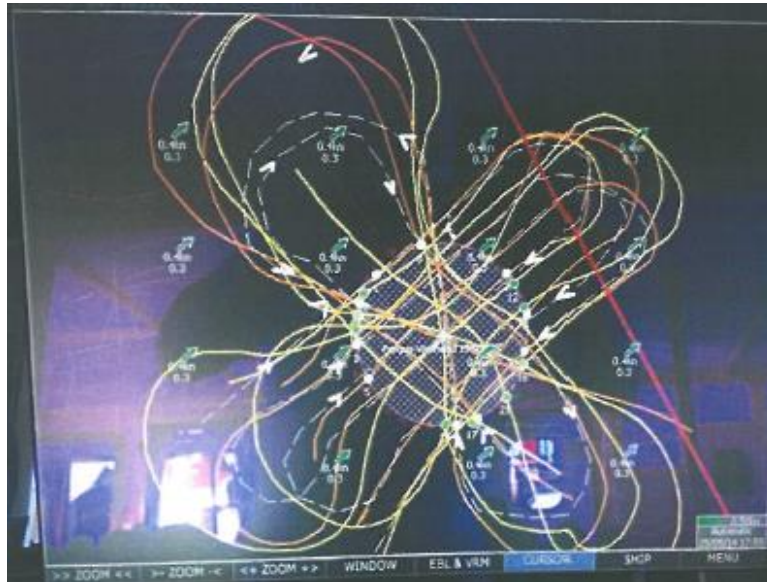
**Figure 7 Typical Sweep Pattern of FFFA Well Centres**

The trawl sweeps covered the 500 metre safety zone of all wellheads from a variety of compass approaches and all existing pipeline corridors in a zig-zag pattern along the length of the pipeline from both ends to provide full and effective coverage.

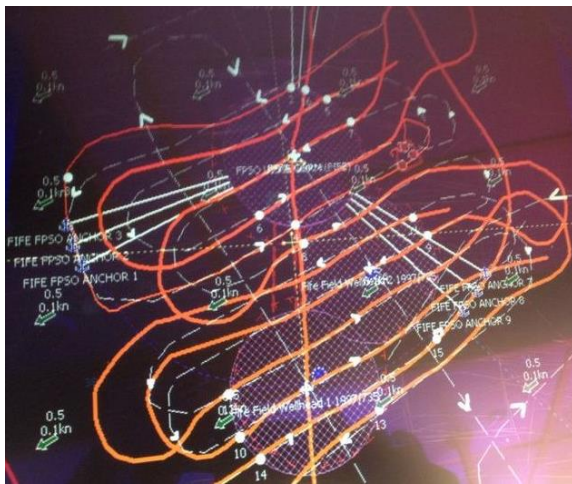
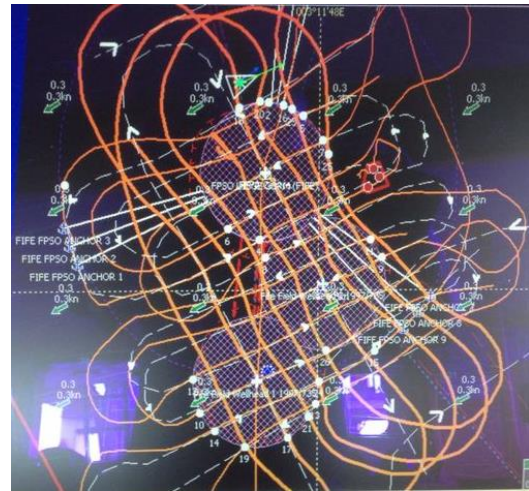
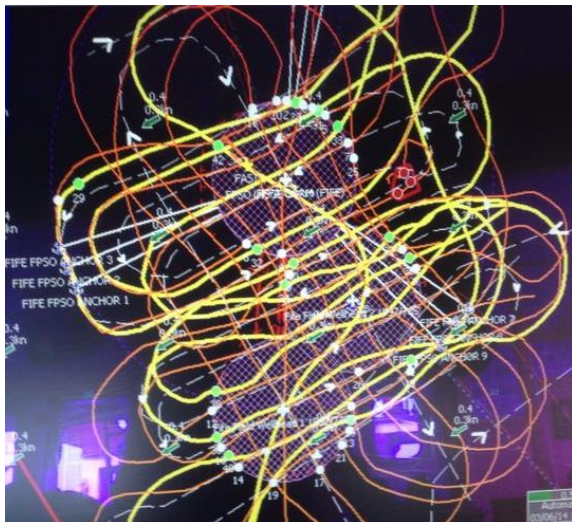
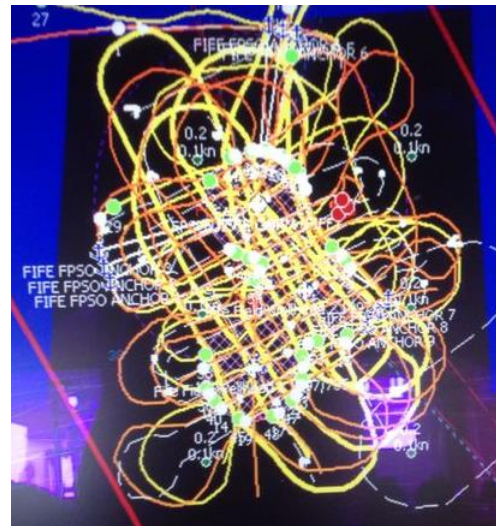
**Figure 9 Fife Central Armorflex Mattress Location Sweep Patterns (FPSO 500m Zone)**

The defined scope of work also included a detailed sweep pattern over the Armorflex mattress rock dump location within the original FPSO 500m zone area to ensure rock dump profile stability and over-trawlability. The vessel completed several sweeps over the area from different compass approaches as shown below in Figure 9, with no snags or hazards identified.

Accordingly the area has been deemed clear for the resumption of normal fishing vessel activities.

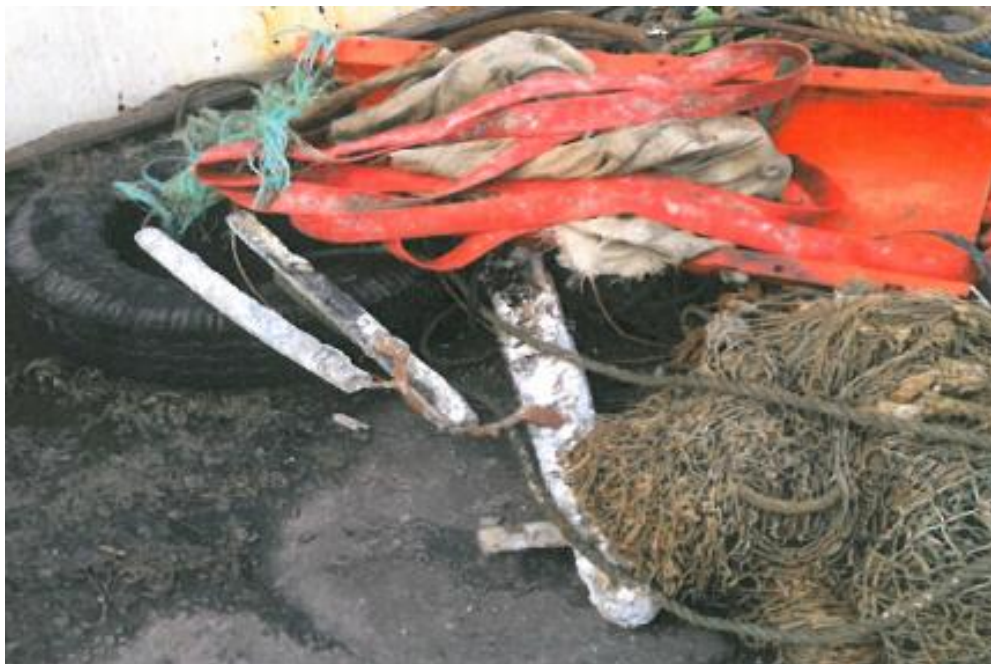
**Figure 10 Typical Debris Recovery From Trawl Sweeps**

During the Fife area chain mat sweeps, a snag hazard on hard debris was identified outwith the defined 500 metre safety zones whilst the vessel was executing a turn to adopt a different approach path to continue sweeping the 500 metre zone. The chain mat could not be released from the snag and was deposited in order to release the vessel and allow further investigation.

The items have not been recovered, the location is noted on the Clearance Trawl Sweep Certificate and both Fishsafe and the UK Hydrographic Office have been informed.

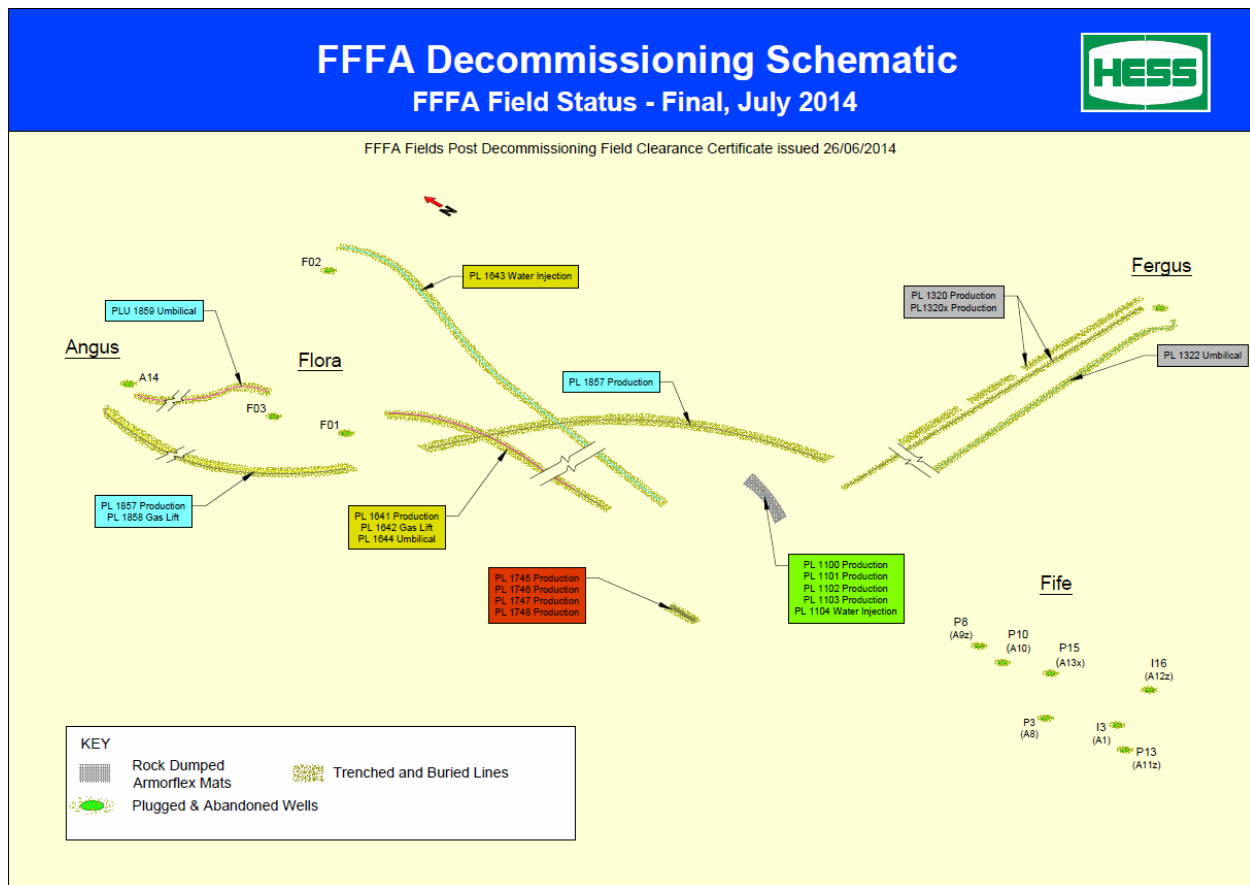
**Figure 11 FFFA Fields Layout Schematic (Post-Decommissioning)**

Data compiled from subsequent surveys and tests give evidence to the final condition of the seabed surface being stable and it is likely to remain so.

Hess has therefore concluded that the FFFA Decommissioning Project has met all its statutory obligations in returning the seabed back to its natural state as far as possible.
