# Sucker rod coupling material solves downhole wear economically

A new sucker rod coupling material enabled a more-than-threefold extension in run times in the Williston basin's Bakken shale, thereby eliminating significant workover costs for the operator and facilitating uninterrupted production.

■ **SETH SILVERMAN** and **LOGAN STONER**, Hess Corporation; **WILLIAM NIELSEN** and **DIANE NIELSEN**, Materion Corporation

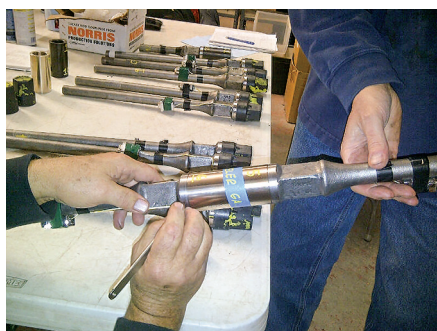
Materion manufactured prototype couplings, following the standard API dimensions for 1-in. slimhole couplings with rolled threads. Controlled make-and-break tests with strain-gauged rods were conducted to assess whether the standard makeup resulted in the required pin pre-stress compared to a T-grade coupling. **Figure 2** shows

**Fig. 2.** New prototype couplings and a controlled makeup/breakout test setup.

both the new prototype couplings and the controlled makeup/breakout test setup. The standard circumferential displacement card value supplied by the rod manufacturer for the 1-in. rod size was determined to be sufficient to deliver good pin pre-tension. The lower elastic modulus of this alloy does not affect the makeup characteristics of this coupling. Subsequent breaks and re-makes of the material demonstrated a return to proper pre-stress levels. The efficient and inexpensive addition of copper plating on the threads and changing of the surface finish on the face of the coupling improved the overall makeup performance.

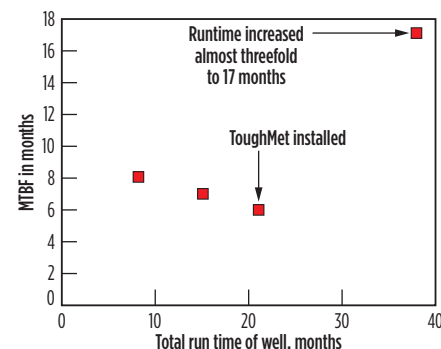
**Fig. 4.** Mean time between failure versus total run time.

In August 2015, after 17 months of production (the longest run time to date on this well), another tubing leak was suspected. The plastic-coated joint just above the pump had a hole. Repairs were made, and the well was put back on production. The operator reinstalled all the ToughMet couplings, with the exception of two for dimensional analysis. **Figure 3** shows a cross-section of one these couplings. **Figure 4** shows the mean time between failure versus total run time.

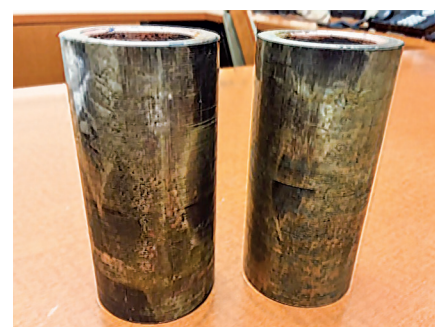
**Fig. 5.** ToughMet couplings after 20 months of service.

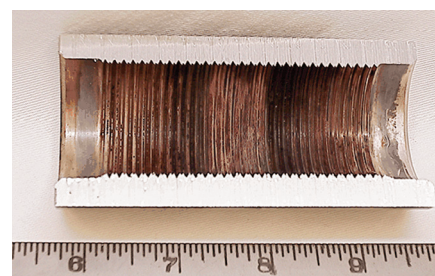
**Fig. 6.** A cross-section of recovered ToughMet coupling.

pump (not in the vicinity of the ToughMet couplings). In this well, T couplings were alternated with ToughMet couplings at the bottom of 26 of the 1-in. guided sucker rods. The inspected tubing shows that there was no significant wear in the area covered by the 1-in. rod string. There was, however, more significant wear and corrosion, above and below the area covered by the ToughMet couplings. **Figure 5** shows the ToughMet couplings after 20 months of service with no noticeable wear on the OD. The serial numbers are still clearly visible, indicating the corrosion and abrasion resistance of the material. For comparison, the OD measurements were taken on a new ToughMet coupling and one of the ToughMet couplings retrieved from the well after 20 months of service. The data show that the change in OD was only 0.020 in. or 10 mils per side. This equates to a loss of only 0.5 mil per month. As expected, the T couplings had a corroded surface and were worn with flat spots. **Figure 6** shows a cross-section of one of the recovered ToughMet couplings.
